KB659.34-35/UK/01 - 06/2016

SUSPENSION

KB659.34/KB659.35

Removal/Installation recommendations

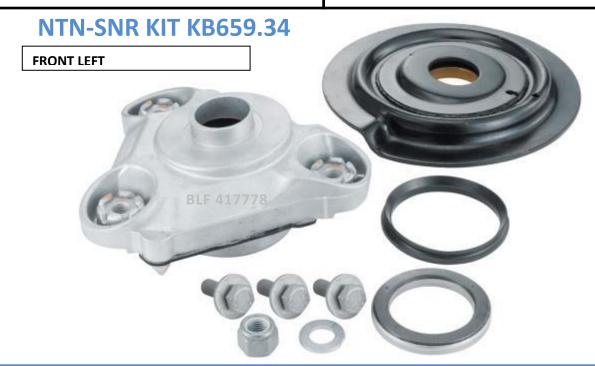
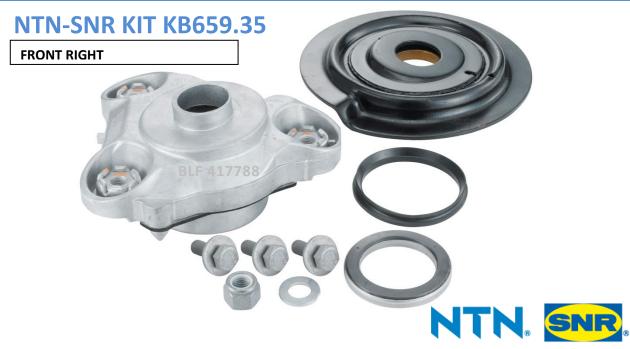
PREMATURE BEARING FAILURE

Incorrect installation of the kit.

Failure is normally caused by the penetration of contaminants such as water and mud. It is important to replace all parts supplied in the kit, in the correct orientation.

The most common failure is normally caused by the two bearings and the two seals being installed backwards (see installation procedure).

- Install the bearing in the correct orientation: the black face of the bearing must sit against the filter unit.
- Install the seal in the correct orientation: the seal lip must sit against the filter unit.
- Take care not to deform or damage the seals during installation, do not lubricate the two assemblies excessively.
