# febi 38548, 100590

Porsche Cayenne, Volkswagen Touareg

## Propshaft Centre Support

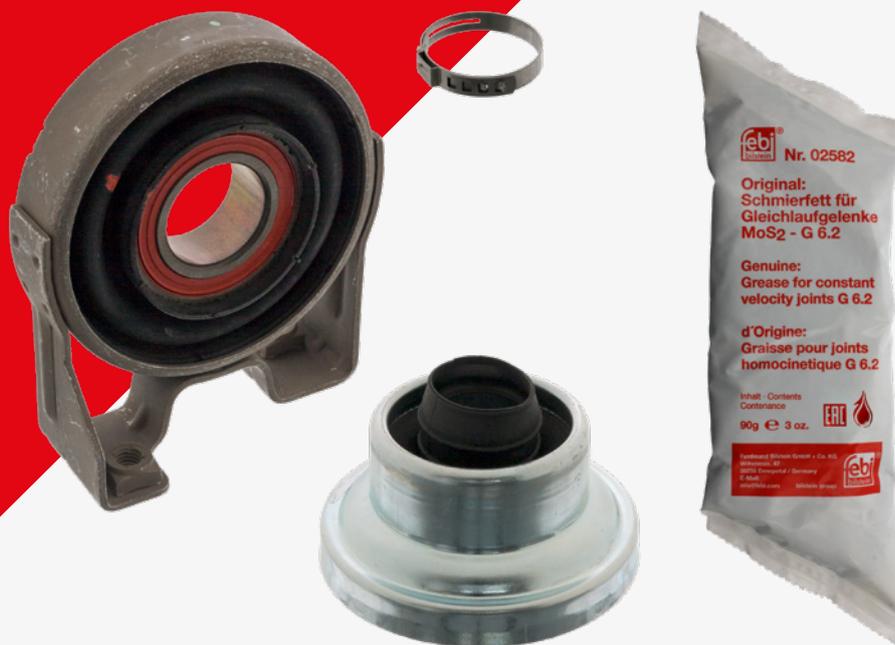
Cracking noises can be heard and harsh vibrations can be felt in the passenger compartment, especially when the vehicle is accelerating or decelerating.

The cause of this can come from a worn propshaft centre bearing rubbing against the propshaft. The rubber of the bearing may split due to wear and tear, leading to noises and vibrations. The worn centre bearing support allows the propshaft to move vertically when changing gear, leaving the bearing unable to support the propshaft. As a result, the component should be replaced.

The propshaft centre bearing is not available separately from the vehicle manufacturer and can only be ordered with the complete propshaft. This makes the repair very expensive. febi offers a repair kit – 100590. This includes the propshaft centre support with integrated roller bearing, protective boot, retaining clip, and grease.
